ROYAL AUSTRALIAN AIR FORCE
INVESTIGATION OF MUSTANG FLYING ACCIDENTS

R. Glassop.....Flight Lieutenant,
Pilot Gunnery Instructor,
Air Armament School.

L. L. Jones.....Engineer,
Directorate of Technical Services

MARCH, 1949

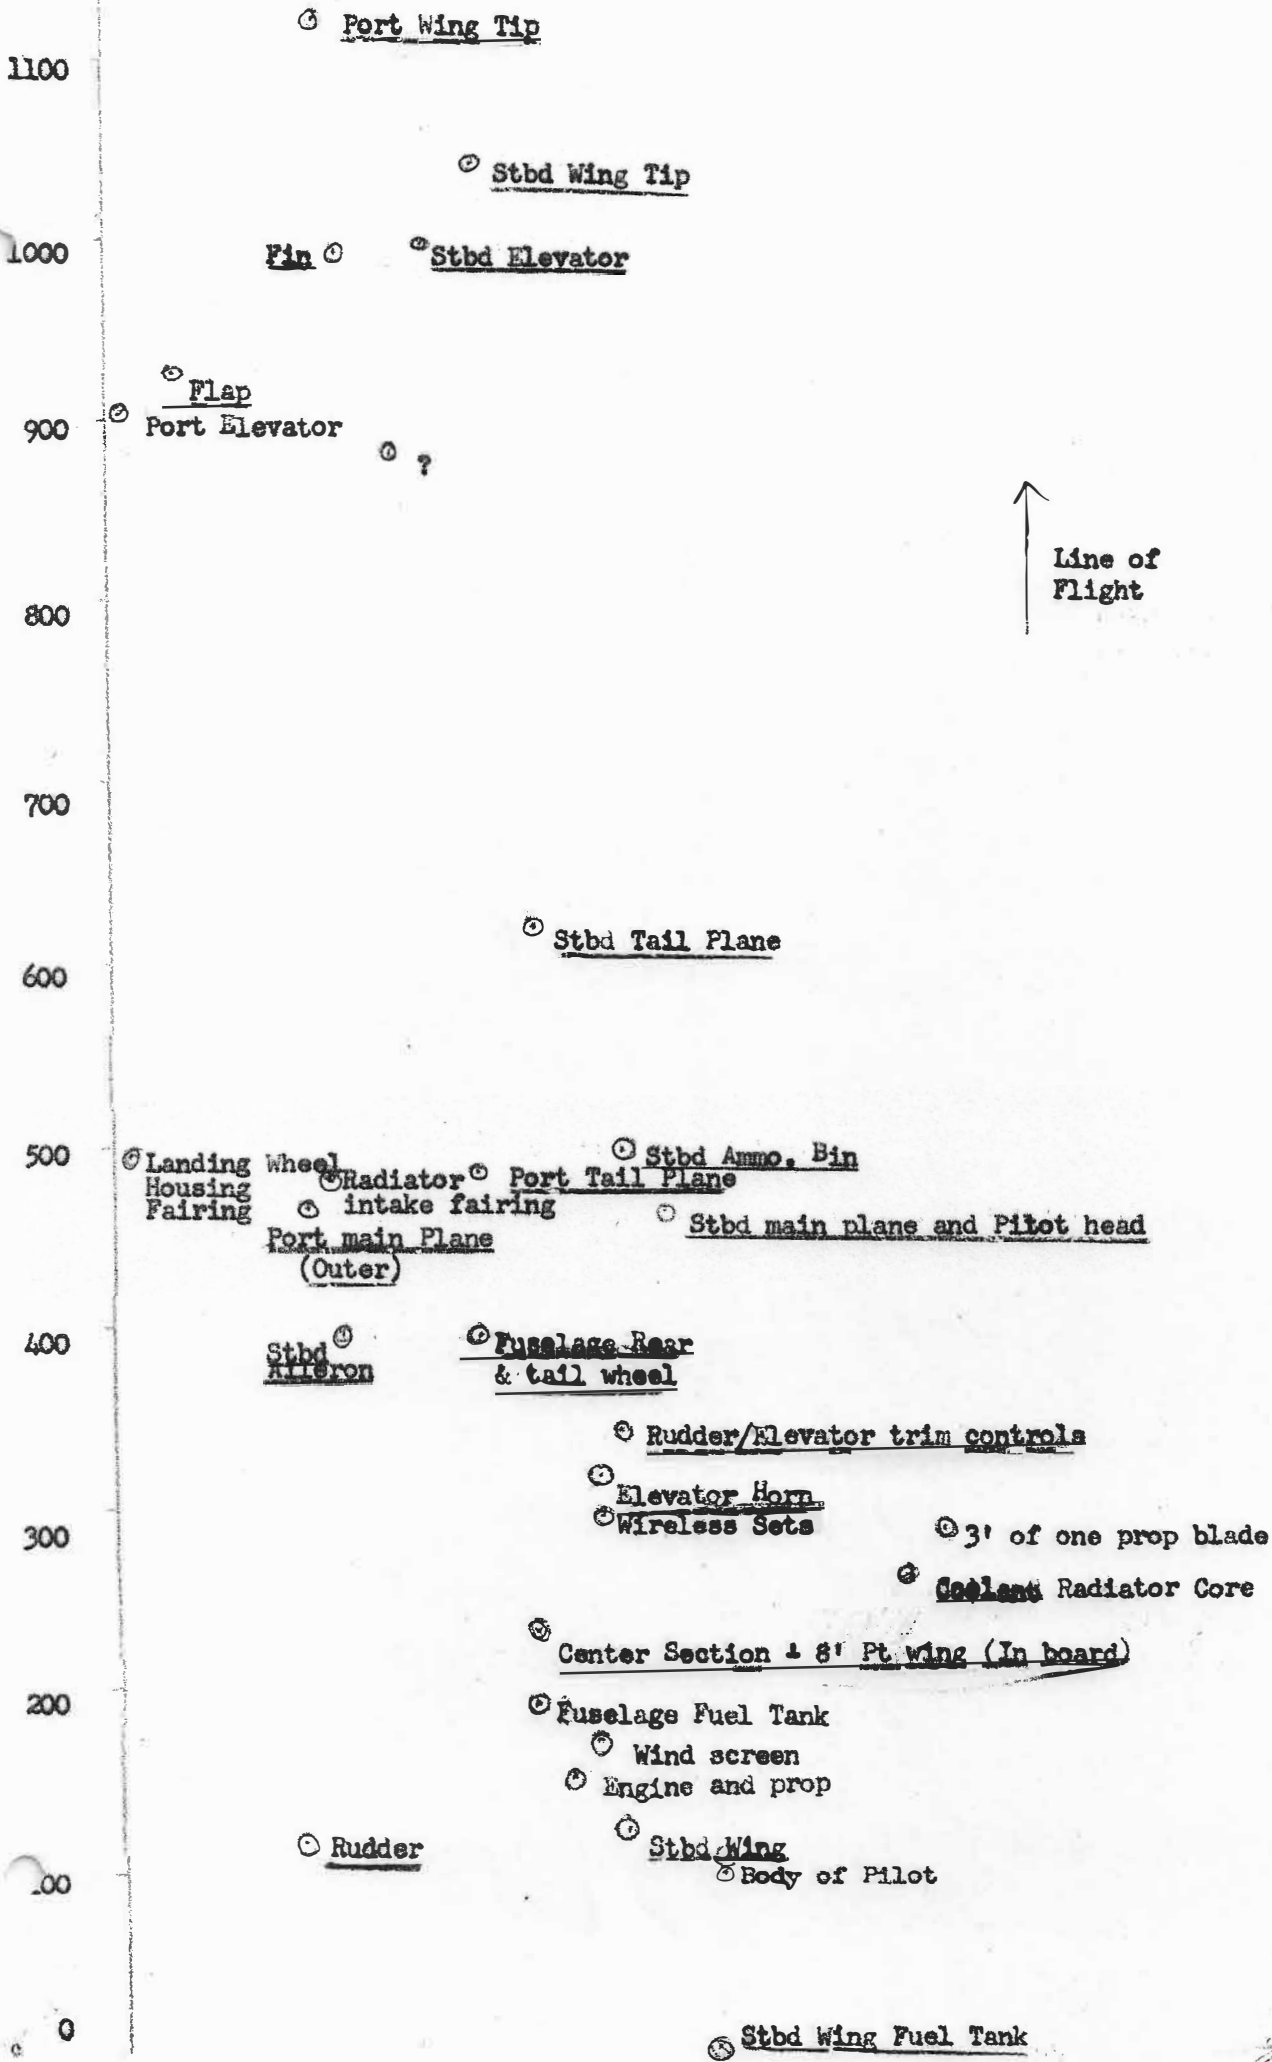
DISTRIBUTION OF WRECKAGE - A68-507
Recovery June 1945.

Statement by the Court: Opinion that aircraft disintegrated at about 2,000 to 4,000 ft. Lack of evidence leaves cause of disintegration obscure.

1200 Miscellaneous Pieces
of Light Alloy & Plastic
